ARMY GROUND RISK-MANAGEMENT PUBLICATION

COUNTERMEASURE

VOL 22 NO 5

MAY 2001

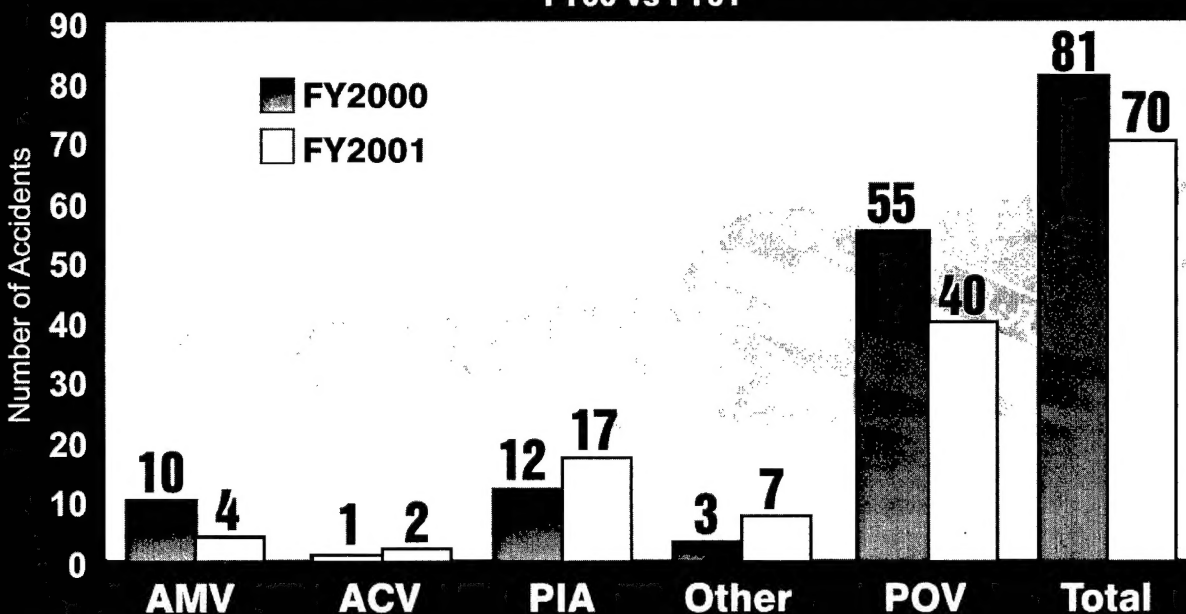
**On-duty Class A Ground Accidents for Mid-year Performance
FY00 vs FY01**

Halfway through this fiscal year, the Army has some good news. During the first two quarters of FY01, the Army reduced the number of Class A ground accidents from 81 to 70 in comparison to the first two quarters of FY00.

The most notable improvement is evident in the reduction of Army motor vehicle (AMV) Class A accidents from 10 to 4 during this timeframe. This is a 60-percent reduction from the previous year and 42 percent below the 3-year average.

POV Class A accidents also declined from 55 to 40 during this timeframe. This reduction of nearly 30 percent over the previous year is a great improvement. However, we still have room to improve, as POV accidents remain the biggest killer of soldiers as well as the leading cause of severe injury.

Unfortunately, the significant reduction in AMV and POV accidents is offset by the increase in Class A Army combat vehicle (ACV) accidents, personal injuries, and "other" accidents. Army combat vehicle accidents

increased from 1 in FY00 to 2 in FY01. Personal injury accidents increased from 12 in FY00 to 17 in FY01. Four of these accidents involved mishandling weapons that resulted in fatalities. Carbon monoxide poisoning was the next leading cause of death claiming the lives of three soldiers. "Other" accidents increased from 3 in FY00 to 7 in FY01, of which 5 were fire fatalities.
